# Impact of Ship Grounding on Coral Reefs in Indonesian Waters

**Abstract.** Indonesia as an archipelagic country is prone to damage to coral reefs. The grounding of ships on coral reefs has resulted in severe physical and biological damage. The grounding of ships on coral reefs has resulted in severe physical and biological damage, including the uprooting and crashing of coral skeletons, dislodgment and displacement of sediment, and loss of three-dimensional complexity. Most of the damage was devastating. The purpose of this study is to identify levels of damage and impact of shipgrounding to coral reefs in Indonesian waters. The research method in this study uses the Line Intercept Transect (LIT) and underwater photo transect (UPT) to measurement of the level of damage and its impact. The result of this study is profile of coral reefs that were predominantly hit by ships was a patch reef (67%) and and mostly occurred due to human error (78%). This research found some types of damage in the form of a trajectory, mounds, propeller, partials, and dispersals. There has been a very significant change in the bottom substrate of the waters both by large, medium, and small vessels. The

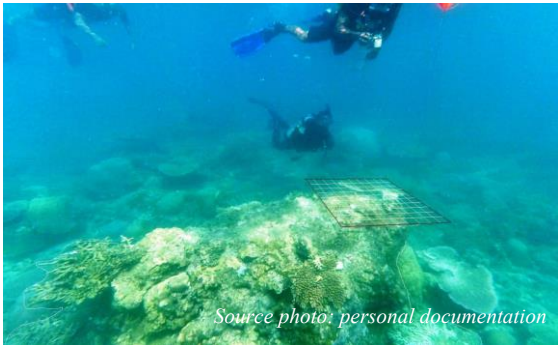
Figure 3. Square grid method (modification from English et al, 1997)

1. Collecting data on the condition of the underwater substrate using the Underwater Photo Transect (UPT) method
2. Collect data on coral species using the belt transect and enumeration method [8], where observers swim in a radius of 2 x 50 m and record each type of coral found on each transect installed.
3. Collect data on the extent of coral reef damage using the Fishbone Method (Figure 2) with a roll meter used as a measuring tool [9] [10].
4. For partial coral damage, specifically the size of the area of direct damage (affected) is obtained using a 1 x 1-meter grid quadrant technique with a 10 cm grid (Modification of English et al, 1997) (Figure 3).

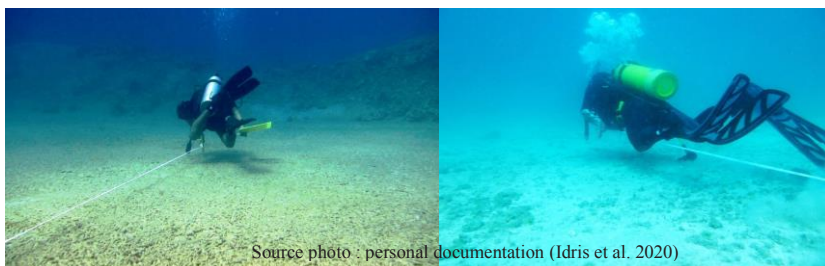
- a. The trajectory Area (Figure 7) is the main area where the ship's body collides, passes, and runs over coral reefs. The main characteristic of damage in this area is that coral reef formations are cut or eroded flat, eliminating the 3-dimensional structure of the coral reef. In this area, sometimes reef flats that have been hit will form like a "canal" with rubble dominant. Often it will also form long mounds of coral reef pieces on the left and right sides like "canal walls" with varying heights ranging from ~0.5 m to more than ~3 m.

Figure 7. Condition of coral reefs in areas crushed by large bulk carrier ships.

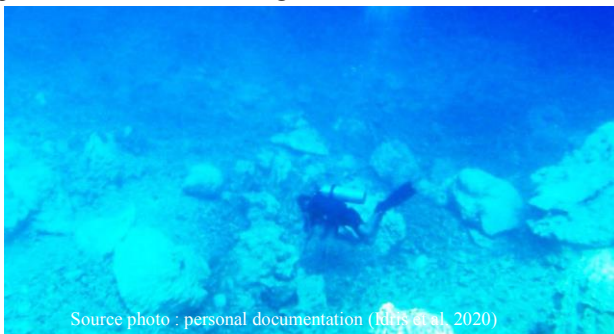
- c. The propeller zone area, (Figure 9) is a reef flat with a certain depth that forms a "bowl/puddle". The number of "bowls" will depend on the movement of the ship when trying to get out of the grounded area. The damage to this area was also very severe, but the form of damage was in the form of coral fragments being lifted and thrown into the surrounding area. The damage can be in the form of split and cut pieces of coral that are larger than rubble.

Figure 9. Condition of coral reefs in the propeller area on large bulk carrier ships

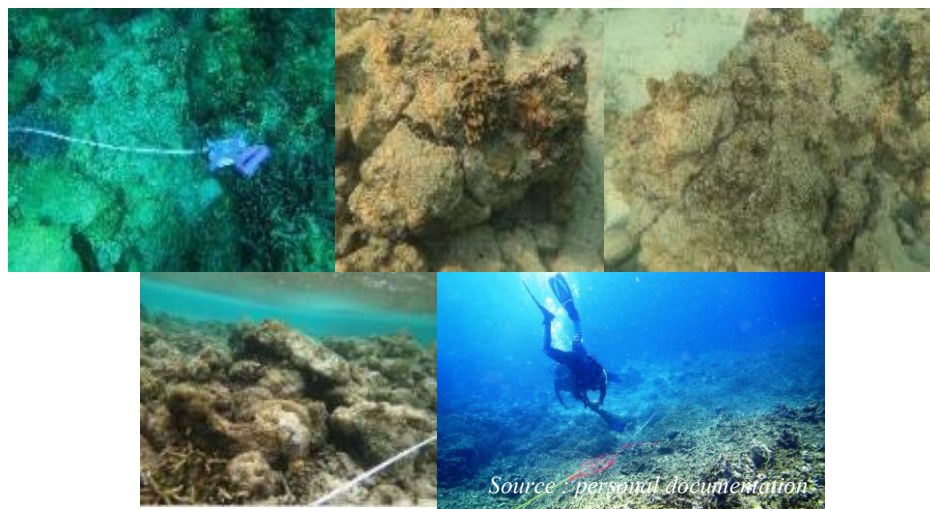
- d. The dispersion zone area (Figure 10) is the area on the left and right sides of the mound area which indirectly follows the dynamics of currents, waves, and storms. This dynamic lifts the remaining sediment and unstable coral fragments and covers the surrounding living coral. The damage in this area was quite severe but did not kill all the coral and benthic biota. The main characteristic of the damage is that live coral colonies are buried or crushed or partially crushed by coral fragments, but this will likely increase in size over time due to the influence of storms or oceanographic dynamics.

Figure 10. Condition of coral reefs in the dispersal area by large bulk carrier ships.

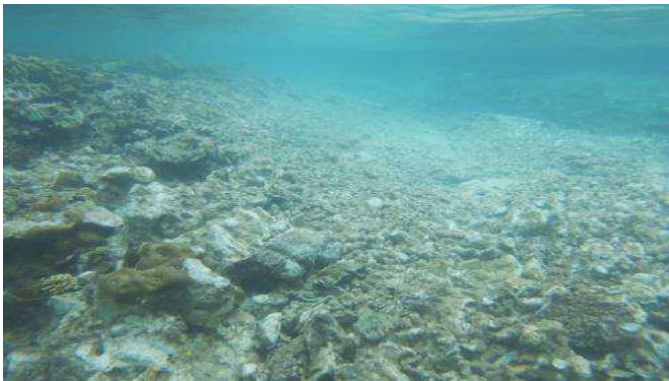
- a. Trajectory area (Figure 12)  
It is the direct impact area or the main area where the ship's body ran aground, collided, and ran over. Severe damage that occurs on shallow reefs is characterized by the type of damage to coral colonies with various growth forms and species. Conditions of damage and mortality reached 100 percent. The pieces of coral colonies form a flat, white track.

Figure 12. Condition of coral reefs in areas crushed by medium-sized barge and LCT vessels

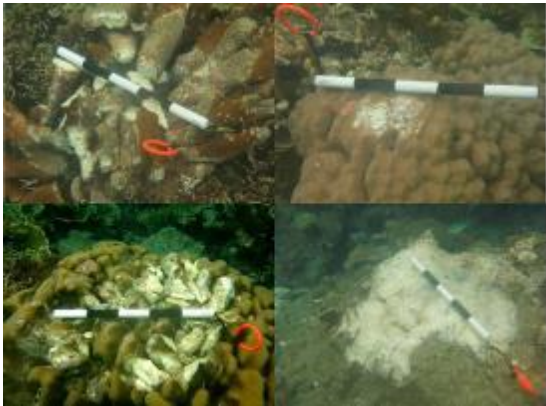
- b. Partial damage area (Figure 13)  
These are points of damage to one or more coral colonies that are spread far apart and occur on relatively deeper coral reefs. The main characteristic is that the coral colony is trimmed or cut, causing the coral colony to break, lift, or turn over, sometimes you can also see pieces of the white limestone skeleton of the coral. For example, several *Acropora* tabulate and branching were also cut and uprooted, leaving fragments of coral colonies around them. Fractures of coral colonies cover other living corals.

Figure 13. Condition of coral reefs in partial areas by small barge and LCT type vessels

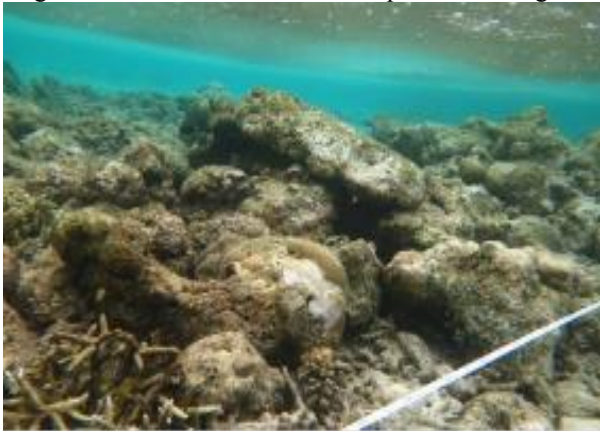
- c. Disspersal Area (Figure 14)  
This is an area indirectly affected in the form of coral fractures and coral colony fragments that fell around the main point of damage.

Figure 14. Condition of coral reefs in the dispersal area by medium vessels (Barge and LCT types)

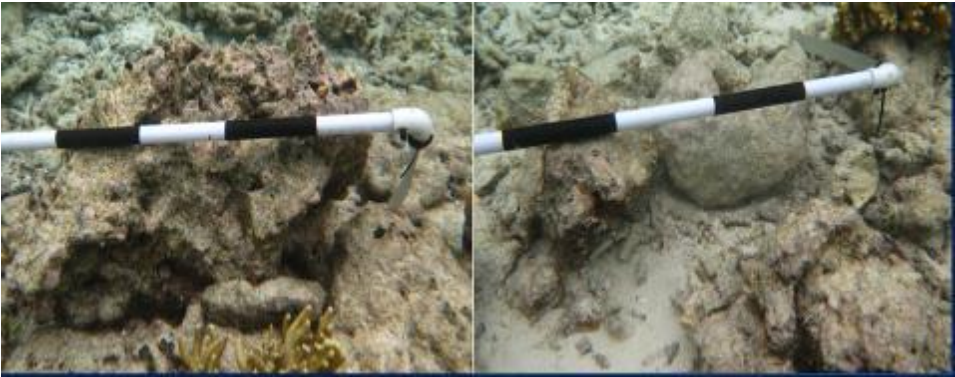
- a. Trajectory Area (Figure 16)  
This is the direct impact area or the main area where the ship's body has run aground, collided, and run over. The crushed coral appears to have died and the coral has turned upside down. Coral colonies split, break, and become large and small chunks.

The force of the impact caused fragments of coral colonies to scatter on the bottom of the waters.

Figure 16. Condition of coral reefs in the area crushed by a small boat (Phinisi type)

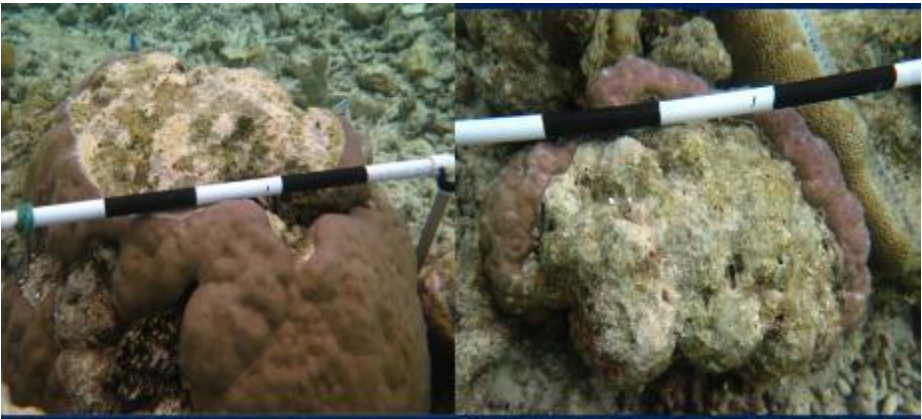
- b. Dispersal Area (Figure 17)  
This is an area indirectly affected by the ship running aground. The main characteristic of the damage is in the form of dead coral colonies that crush or impinge on surrounding living coral colonies, due to oceanographic dynamics. This condition causes several living coral colonies to die and widespread damage.

Figure 17. Condition of coral reefs in the dispersal area by small phinisi type boats.
