# Evaluation of the state of the civil engineering structures in the province of Fes-Moulay Yacoub-Morocco

The objective of this article is to demonstrate the stages of the inspection mission carried out on the heritage of works of art in the wilaya of Moulay Yacoub.

With the aim of preserving the heritage of the Structures of Art, a mission was carried out in the province of Fez-Moulay Yacoub in order to ensure an inspection of the various existing bridges at the level of the road network. The structures concerned by the inspection are those defined in the "Instruction for the monitoring and maintenance of engineering structures", namely:

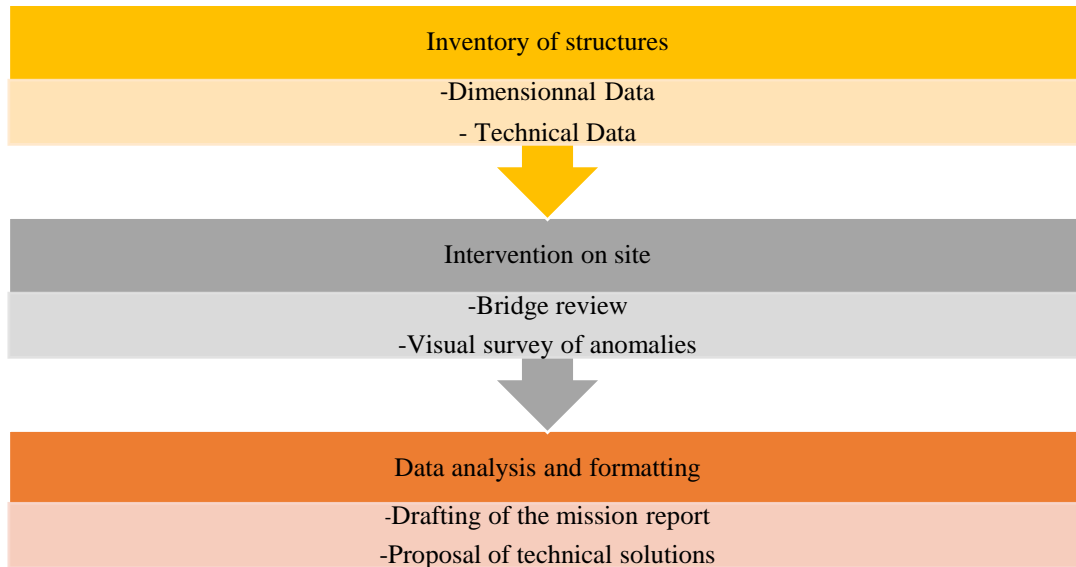
The following synoptic represents the essential steps of an inspection mission:

**Fig. 1.** Steps of an inspection mission

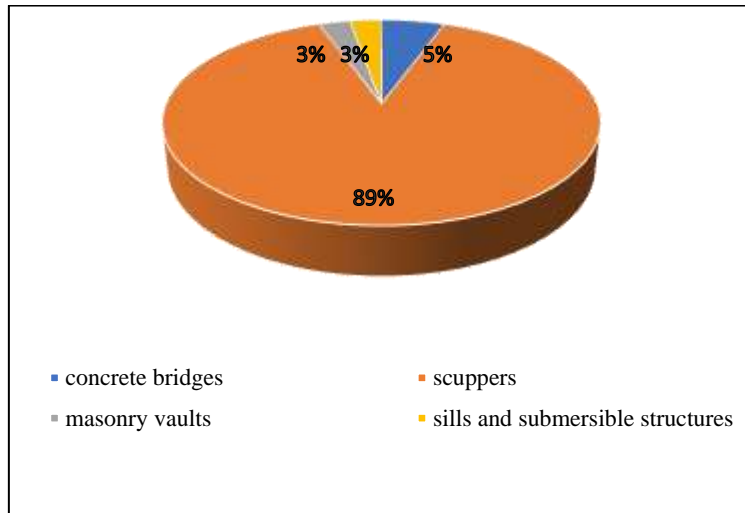
- 4 Concrete bridges;
- 64 scuppers;
- 2 masonry vaults;
- 2 sills and submersible structures.

Fig. 2. Distribution of bridges by family

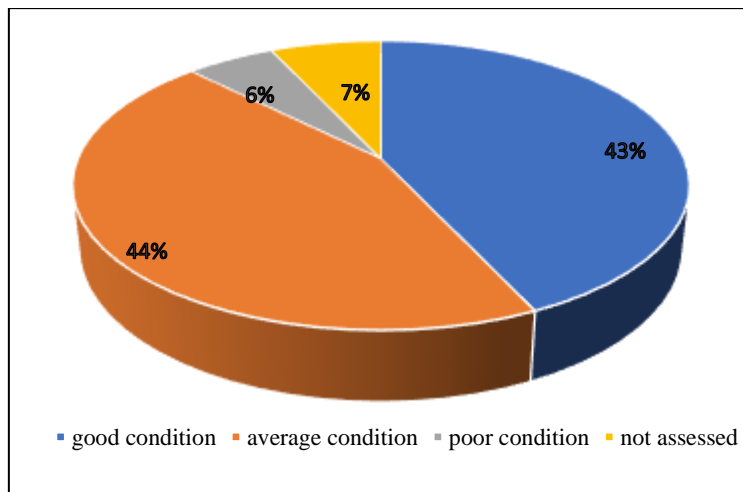
- 30 structures are in good condition (grade 1 and 2);
- 31 structures are in average condition (grade 3);
- 4 structures are in poor condition (grade 4 and 5);
- 5 structures are not assessed.

Fig. 3. Distribution of bridges by health status

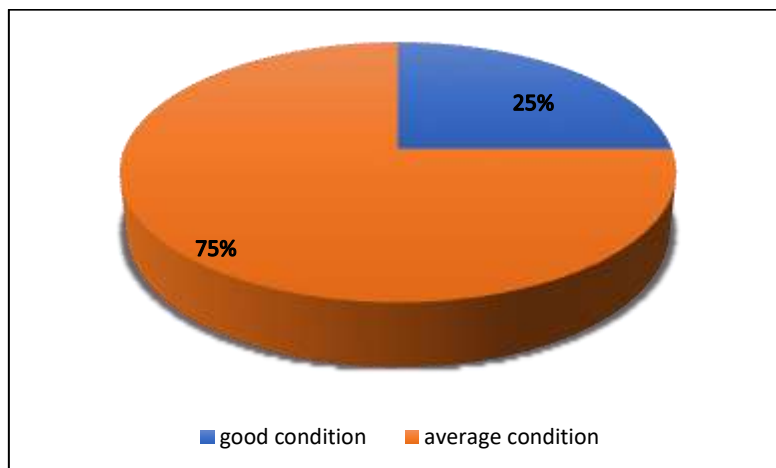
The number of bridges that were the subject of this mission is therefore 4. 3 are in average condition and the last one is in good condition. The distribution by condition class is as follows:

Fig. 4. State of health of concrete bridges

25% of the inspected structures (1 structure) are in good condition. These structures show defects or degradations that are localized and superficial. However, the defective equipment and protections must be replaced to ensure the durability of the structures. 75% are in an average condition. These bridges show minor defects that require surface treatment and protection against the risk of short-term evolution of the structure to bad classes (grade 4 and 5).

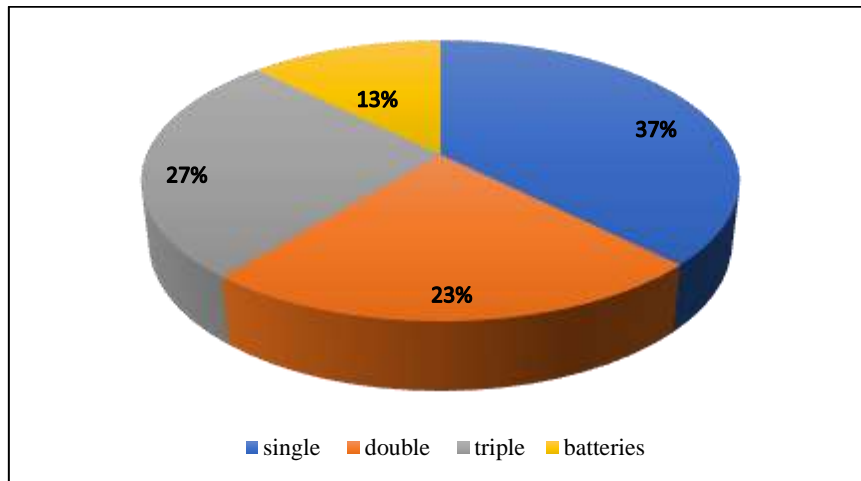
- 24 single scuppers,
- 15 double scuppers;
- 17 triple scuppers;
- 8 batteries of scuppers.

**Fig. 5.**Distribution of scuppers by sub-family

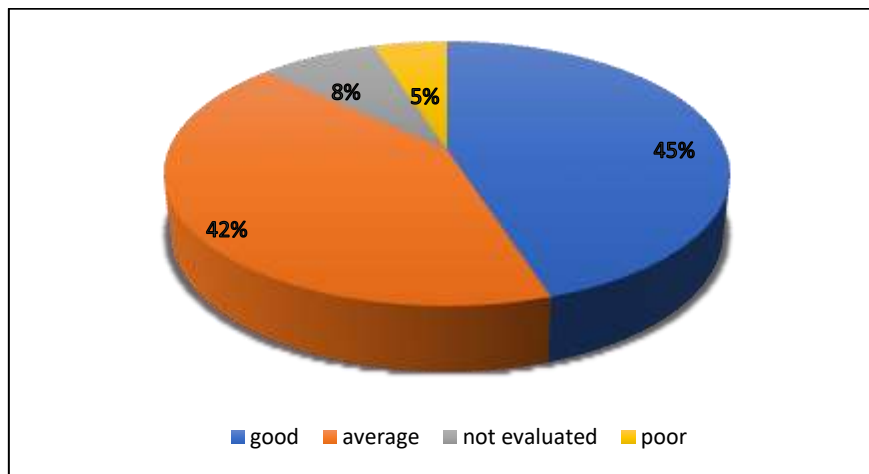
**Fig. 6.** State of health of scuppers

- 45% of the scuppers have a score of 2 or less, which means that these structures have localized and superficial defects or deterioration;
- 42% of the scuppers have a score of 3. These structures must be repaired to ensure the durability of the structure;
- 5% of the scuppers are in poor condition and require urgent intervention to avoid compromising the stability of the structures;
- 8% of the scuppers have not been evaluated because of their blockage and / or difficulty of access to the slab and pedestals.

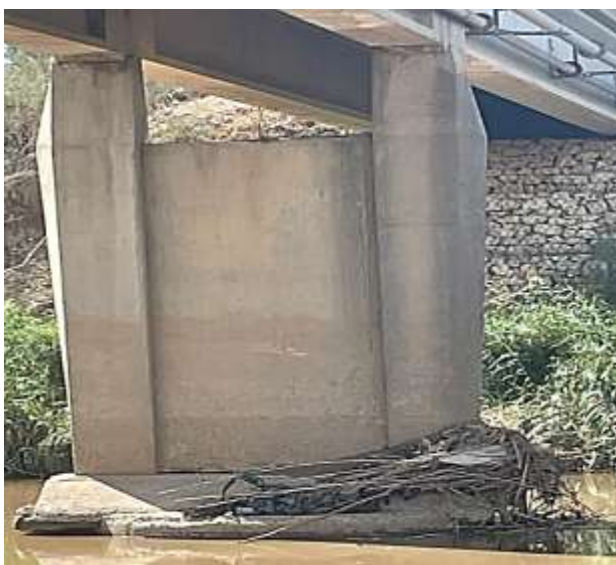
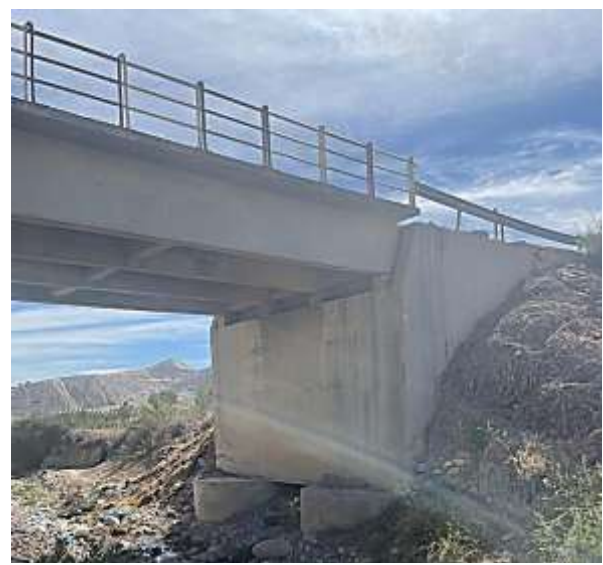
During this mission, it was noticed that most of the degradations suffered by all the inspected structures are due to the water flow and to the scouring phenomenon which can sometimes lead to the collapse of the structures. Scouring is a phenomenon caused by the flow of water in rivers, and is translated by the displacement of sediments as a result of the erosive action of water [3]. The instability of the structures caused the lowering of the level of a river bed especially when the flood is very severe and the scouring pit is very pronounced [4].

The two figures below present the apparition of scour phenomenon near the foundations of two bridges situated in national roads and that needs protections.

Fig.8. Manifestation of scour phenomenon in inspected bridges (a)piers (b)abutments

- Carry out regular routine maintenance;
- Proceed regularly to the cleaning of the clogged works;
- Put in place adequate protection against scouring;
- Proceed to the repair of the noticed cracks;
- Proceed to the treatment of the disjunctions of the masonry works;
- Proceed to the protection of the exposed steels;
- Proceed to the regular maintenance of the guardrails and the equipment of the works of art.

This technique involves placing boulders in scour holes. Indeed, this technique is the most widely used in Morocco, given its effectiveness in protecting against this phenomenon if the technique is very well executed. However, it is very important to include a filtering layer between the riprap and the bed to reduce the risk of sinking, since the bed materials are fine and mobile. The filter layer is traditionally composed of gravel with a grain size of 1-200mm (minor riprap) followed by a layer of major riprap. When flooding occurs, the riprap may be displaced downstream, requiring regular recharging during low-water periods, hence the need for periodic inspections to determine the need for riprap [17].
