Mapping Embankment Dam Geomorphology Using Unmanned Aerial Vehicles (UAVs): A Case Study of Bukit Kwong Dam, Kelantan, Malaysia.

Abstract. Dam hazards impose huge risks to the community as well as infrastructures. Obtaining and comprehending terrain features through geomorphological mapping is vital for dam area as it enables prediction of potential future terrain changes. The utilization of Unmanned Aerial Vehicles (UAVs) has garnered significant interest in geological, geomorphological, and geotechnical studies owing to their capacity to acquire high-resolution data from challenging structures like dams. This paper aims to assess the geomorphology characteristics such as topography of the embankment dam located at Bukit Kwong Dam, Kelantan Malaysia by utilizing the photogrammetric images acquired from UAV including Orthomosaic, Digital Surface Model (DSM) and points clouds using Structure from Motion (SfM) approach. An accuracy assessment for the generated DSM containing topography information was made to prove the reliability of the data. As a result, the millimetre uncertainty in the form of Root Mean Square Error (RMSE) was calculated approximately 8.04 mm and 0.33 mm for bot

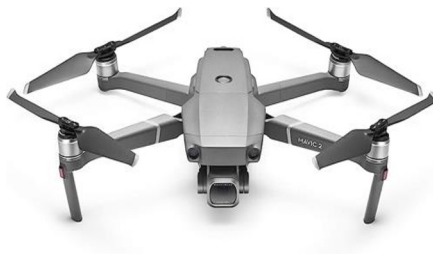
Figure 2. DJI Mavic 2 Pro.

A rotary wing type of UAV with an integrated RGB (Red, Green and Blue) sensor, DJI Mavic 2 Pro (Figure 2) was used as a data image collector surrounding the dam area. This type of UAV has an advantage of being able to hover, take-off and land vertically besides of having better manoeuvring capability to get as close to the dam structure compared to a fixed wing UAV. The technical specification is shown as Table 1.

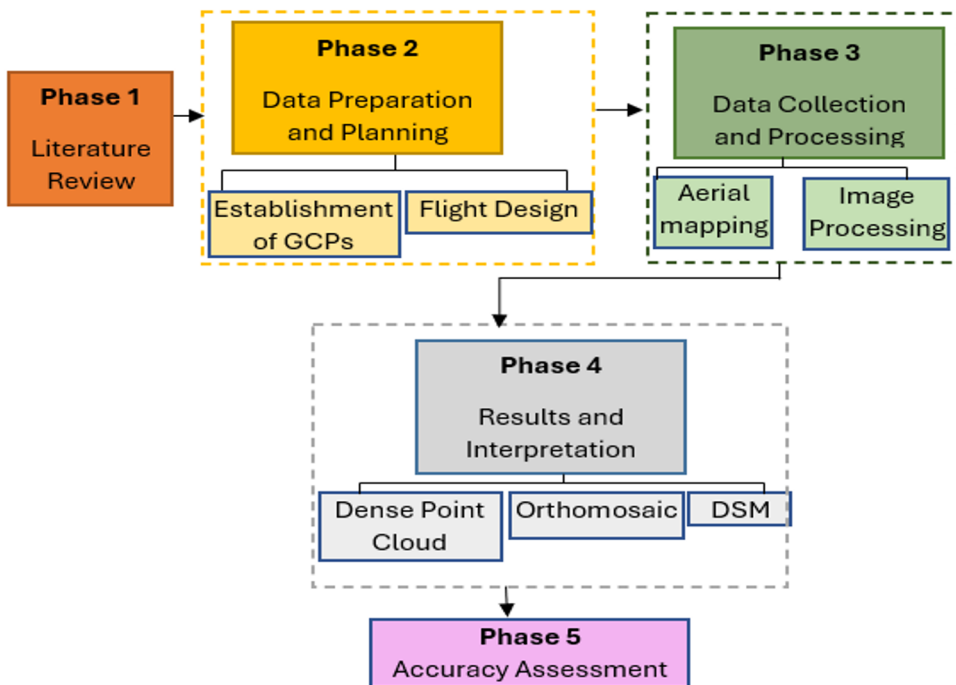
Figure 3. Flowchart of research methodology.

There are five main phases involved to achieve the objectives of the study including (1) Literature review, (2) Data preparation and Planning, (3) Data Collection and Processing, (4) Results and Interpretation and (5) Accuracy Assessment as per illustrated in Figure 3.

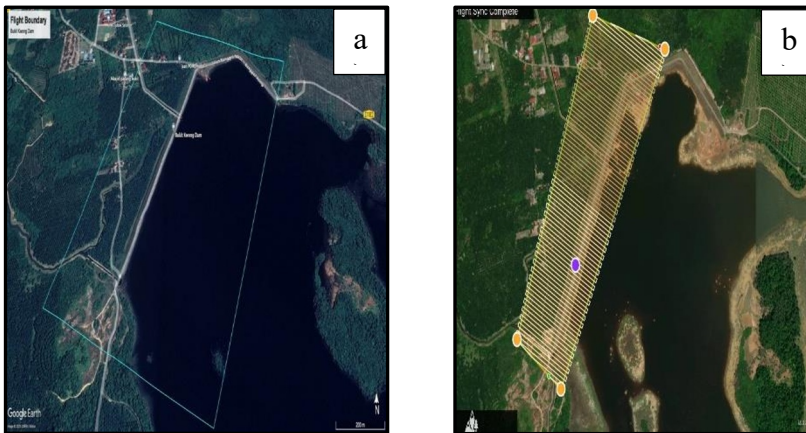
Figure 4. Flight design of UAV survey. (a) Flight boundary and (b) parallel-axis flight lines of Bukit Kwong dam for UAV operation that includes dam, downstream and upstream area. Boundary mission was constructed in Google Earth in KML format and exported into UAV.

The routes of the UAV were planned by ensuring the area of interest aligned within four coordinates, $5^{\circ}57'30.10''\text{N}$ $101^{\circ}57'30.61''\text{E}$, $5^{\circ}57'22.09''\text{N}$ $101^{\circ}57'57.89''\text{E}$, $5^{\circ}56'42.67''\text{N}$ $101^{\circ}57'41.85''\text{E}$, and $5^{\circ}56'51.79''\text{N}$ $101^{\circ}57'16.56''\text{E}$ as shown in Figure 4 (a) and (b). The area is free from power transmission line to avoid interference of signal with the photogrammetric configuration of 90% overlap and 85% side lap. All permits were obtained for site entry permission by Department of Irrigation and Drainage DID Kelantan State Director as well as Civil Aviation of Malaysia CAAM for flight permission. The boundary flight path of the study area was drawn in Google Earth using polygon shape and was imported to the DJI Go 4 app in an iPad that was connected via the cable to the remote controller.

The flight and image acquisition were executed autonomously according to predefined flight path as per Figure 4 (b). Seven GCP targets were placed accordingly and were observed using spot measurement system. The details of technical parameters are indicated in Table 2.

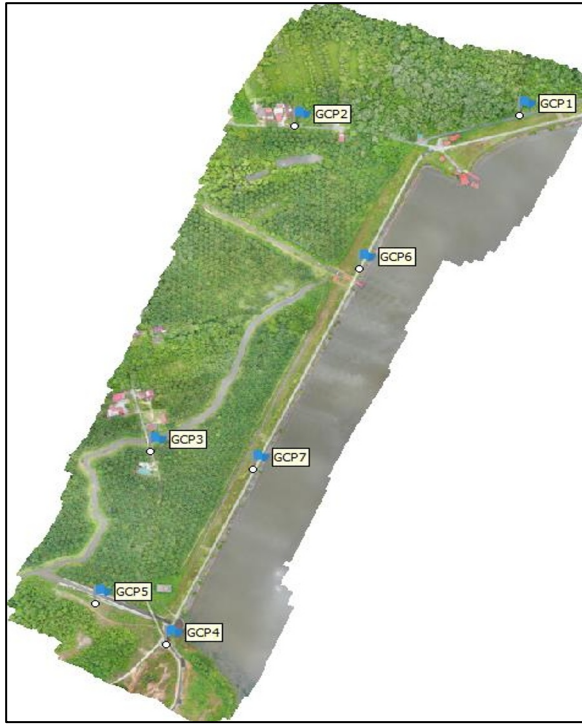
Figure 8. The distribution of seven ground control points in study area. Two GCPs (GCP 6 and 7) located at centre on embankment crest, while five GCPs located at upstream (GCP1, GCP 2), downstream (GCP 4 and 5) and at upper edge (GCP3) of study area.

The accuracy, distribution, and number of GCP can greatly influence the accuracy of DEM derived by UAV in different types of terrain [8]. There was a total of seven (7) GCPs targets where two of GCPs were located on the embankment area and the rest were distributed at the downstream and upstream area before the UAV mapping. The GCPs were measured using static network with a South Galaxy G7 base and rover. The GPS base station was first set up and observed on a stable ground and free from large obstacles within the study area for over 30 minutes of observation and all the GCPs location was measured and recorded using handheld rover. The coordinates were collected in the form of Easting (X), Northing (Y), and Elevation (Z) of GCPs and were processed simultaneously by connecting the points to the base station during data processing using Topcon Tool software.

Table 3 summarized the RMSE in three coordinates direction of X, Y and Z error for each distributed GCP (Figure 8) which were obtained in millimetre (mm) accuracy. The XYZ errors were seen extremely low errors values ranging from -12 mm to 7 mm. The RMSE value for horizontal error was calculated approximately 8.04 mm using the Equation 4 and the accuracy for vertical was approximately 0.33 mm. The data was seen exhibited a larger error along the horizontal axis than the vertical axis. In UAV photogrammetry, it is widely acknowledged that horizontal accuracy tends to be slightly superior to vertical accuracy, except in cases of complex topography such as hilly areas and sloped terrain [3]. An embankment dam is usually situated in a high relief area where typically has higher horizontal RMSE between $1 \times \text{GSD}$ to $7 \times \text{GSD}$ and a vertical RMSE between $1.5 \times \text{GSD}$ to $5 \times \text{GSD}$ as reported by various studies [12,13]. Generally, the quality of the produced DSM was found extremely better as compared to the study by [14] with the RMSE accuracy of 0.20 meter using a high GCP density (40 GCPs) distributed in a small survey area (0.2 km^2).

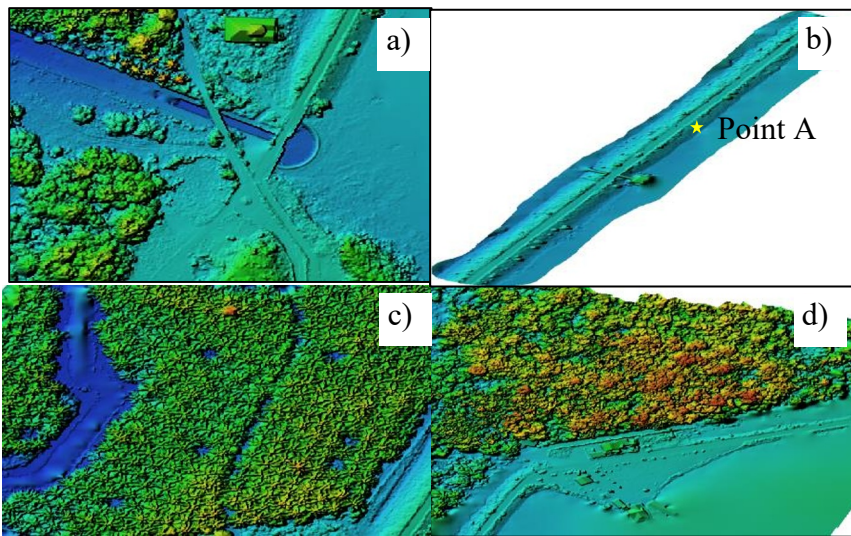
Figure 10. The geomorphology based on the reconstructed digital surface model of the study area a) flat and low dissected plateau, (b) moderate straight steep terrain. Point A was extracted to retrieve morphometric information, (c) flat valley with vegetation cover and (d) moderate dissected hills and valley.

The geomorphology of the study area were identified consisting of flat and low dissected plateau (Figure 10 (a)), flat valley with vegetation cover consisting of river (Figure 10 (c)), moderate dissected hills and valley (Figure 10 (d)) and moderate straight steep terrain across the reservoir (Figure 10 (b)). The morphological characteristics (i.e., slope, aspect, elevation) of Point A (Figure 10 (b)) at the embankment fill was selected randomly and extracted from the DSM using ArcGIS software to represent and highlight the features of the area. As shown in Table 4, the slope angle at the Point A is 15 degree in the direction of northeast with moderately high altitude at 24.8 meter. In an embankment dam, slope angle of 15 degree could become critical if the factors like water saturation or poor soil cohesion are involved [16]. Moreover, if the direction of the slopes are facing with an extreme precipitation possibly leading to a higher moisture retention and thus susceptible to saturation and potential instability especially at higher elevations [15]. According to [17], the surface landform features such as slope angle, aspect and elevation are crucial as primary data in the study of slope instability and movement of soil mass or landslide. In addition, layering multiple parameters of various resources (e.g. lithology, rainfall, soil), a significant instability events can be defined in the study area liable to comparatively high or else low probability or probability classes [16].
